## Inspection Report Summary

**Date of Inspection:** *October XX, 2003*

Inspection Summary for Property  
Located at  
XXXXXXXXXXXXXX  
Dallas, Texas 75XXX

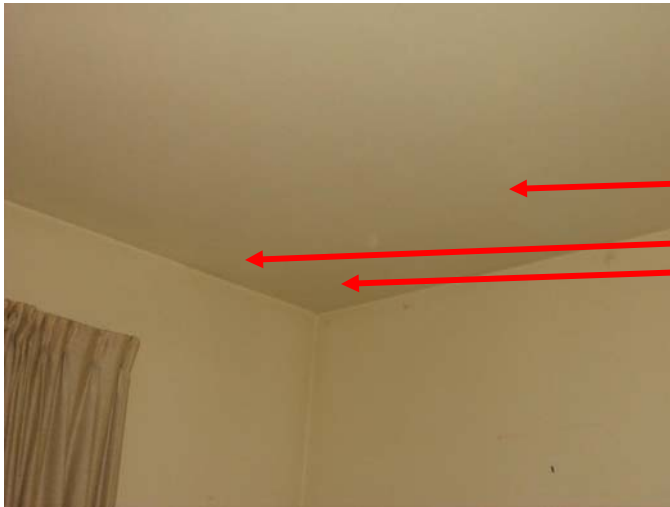
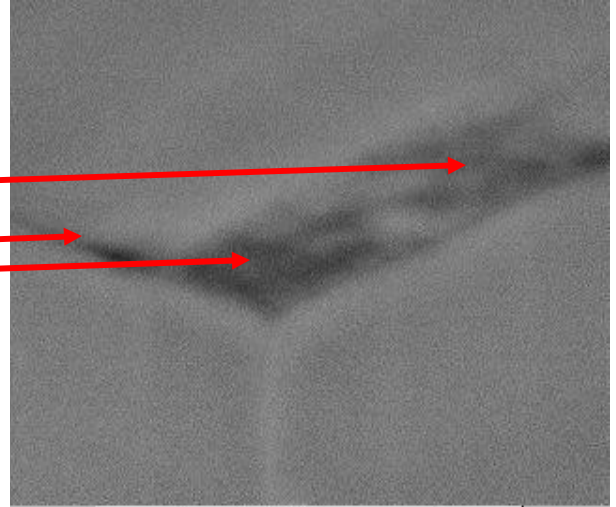
**First bedroom southwest corner at ceiling.**

The Mayfield Thermography Consulting Services proprietary infrared analysis indicates historical and active moisture intrusion and moisture retention within the wall and ceiling cavities. Some, limited moisture intrusion is typical in most residential construction. In some cases, this water easily leaves the structure with no accumulation with proper attic ventilation. When the water does not leave the structure due to poor attic ventilation, its cumulative effect can cause long-term (and often accelerated) deterioration of the structure. In many types of residential construction, more water enters than can exit. When this happens, there is a gradual increase in the amount of retained moisture and moisture accumulation within the wall and ceiling cavities. Moisture signatures, such as some of those identified in much of this house, are not indicative of saturated water presence, but of a widespread and growing accumulation of moisture vapor and some condensation being retained in the insulated wall and ceiling cavities. Such accumulations of moisture vapor and condensation should not cause immediate and catastrophic structural failure, but would be expected to be associated with long-term deterioration. Further, some mold / fungi growth may be associated with this type of moisture in addition to the increased possibility of drawing the presence of termite and wood ants. Based on our experience there could be some possibility of localized hidden damage. Analysis for mold / fungi, hidden damages, and insect colonies requires intrusive inspections, and is beyond the scope of this non-invasive inspection. It is therefore recommended based on our visual and infrared inspection that the anomalies we have identified should be investigated and validated by a third party Roofing / Engineering Consultant and Indoor Air Quality Testing Firm.

Wet insulation around the perimeter of this house needs to be removed and replaced in addition to all damaged sheetrock. Verify the amount of blown insulation and/or batt type insulation is sufficient to achieve the proper R-Value to prevent costly utility bills.

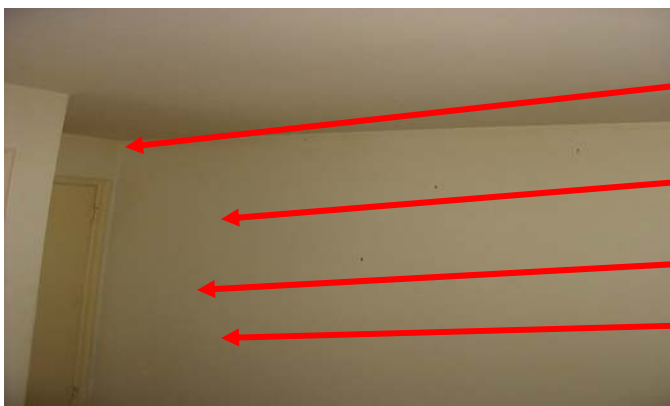
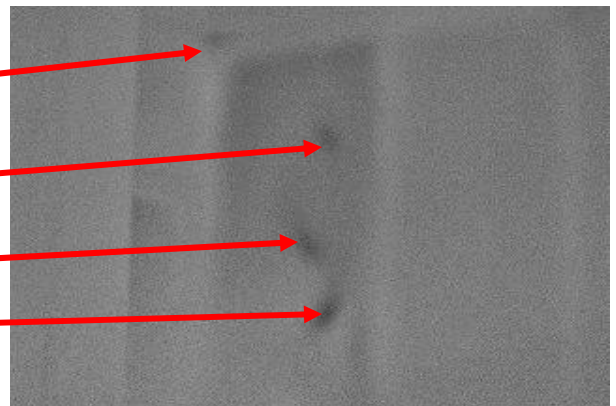
**First bedroom northeast corner wall by entry opposite hot water heater closet.**

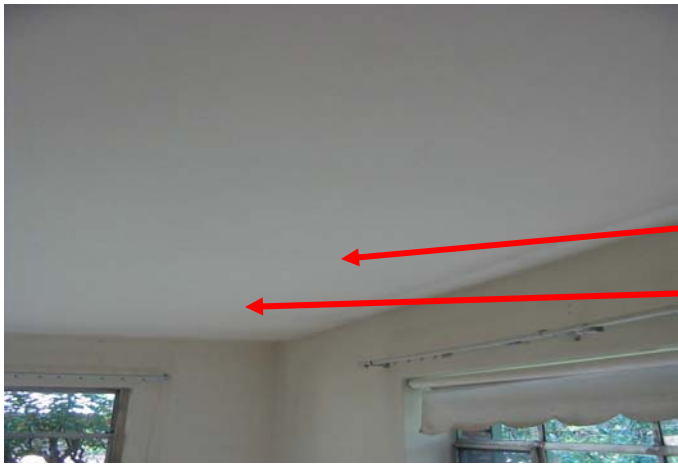
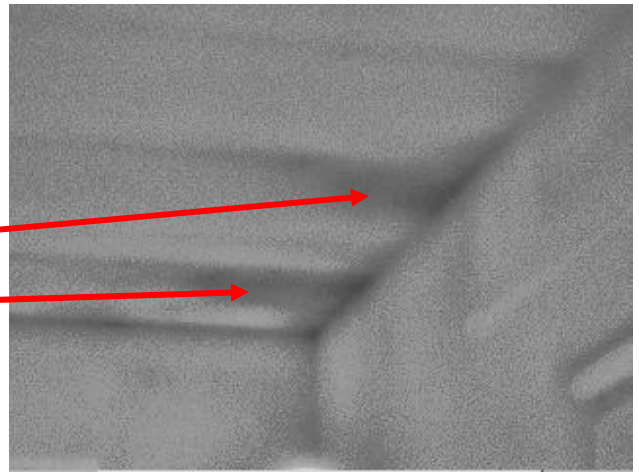
**Second bedroom southeast corner ceiling.**

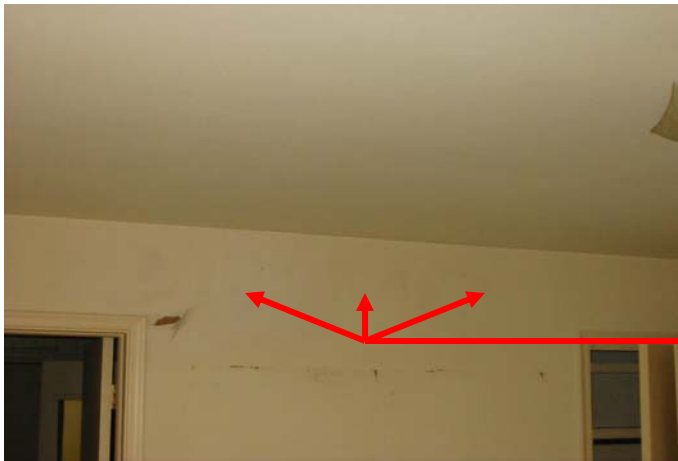
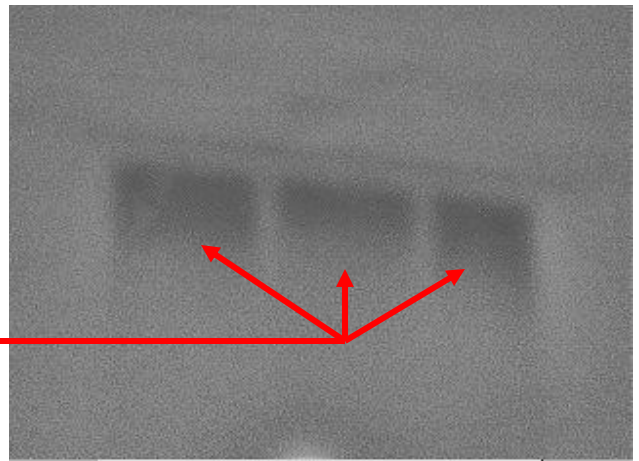
**Second bedroom west wall at ceiling opposite shower.**

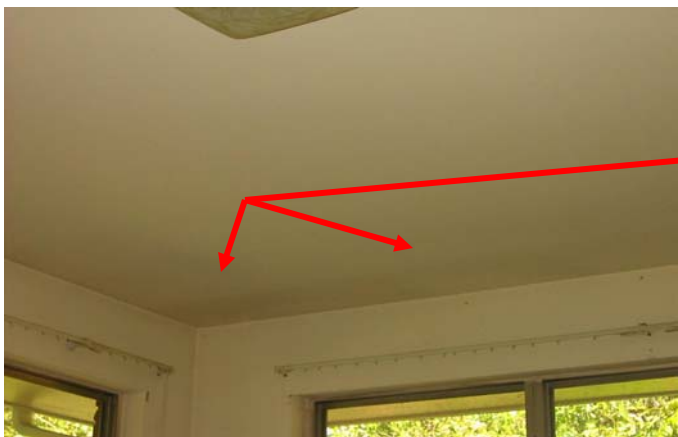
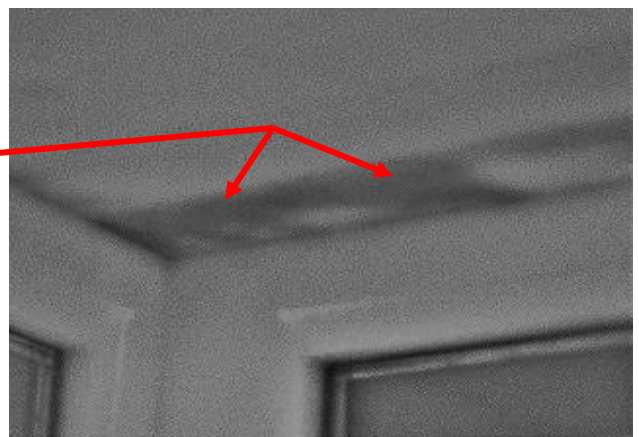
**Master bedroom northeast corner ceiling.**

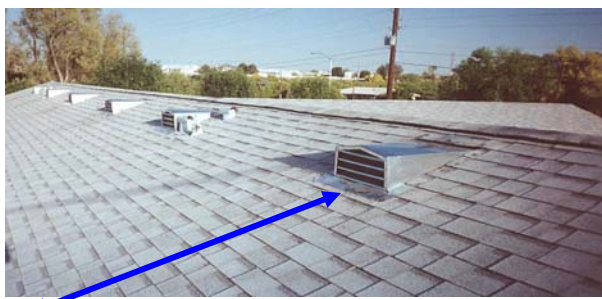
**Dormer vents installed on a composite roof.**

The existing overlay composite roof on this house is in good shape but does in our opinion need additional attic ventilation by adding power vents or by adding four to six dormer vents. The pictures below are of typical installations of dormer vents on a composite roof and tile roof. All roof edge flashing, valley flashing, vent stacks, chimney flashing and any other type of roof penetrations should be inspected and verified that all are sealed in a “watertight” manner by a third party roofing / engineering consultant. Once the roof is secured and waterproofed and all air conditioning vent boots are replaced or corrected to prevent condensation problems and all damaged interior drywall is replaced. A final infrared inspection should then be performed to look for any possible leaks or deficiencies and to validate the entire correction process. Mayfield Thermography Consulting Services would be happy to validate the correction process.

Power vents or the addition of four to six dormer vents should be installed to increase the amount of attic ventilation. The correct number of vents (square inches) required by local building code should be installed. These vents should be only the highest quality vents, which are guaranteed not to leak.

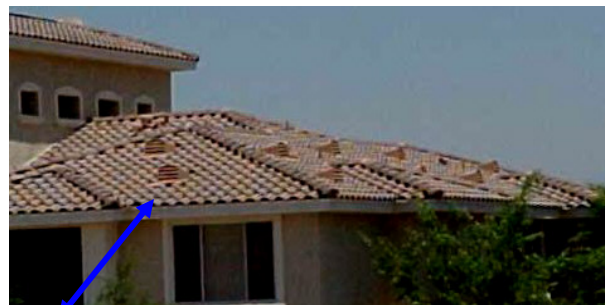
**Dormer vents installed on a tile roof.**
